Technical Report

**CORROSION OF MATERIALS
IN HYDROSPACE**

U. S. NAVAL CIVIL ENGINEERING LABORATORY
Port Hueneme, California

Technical Report R-504

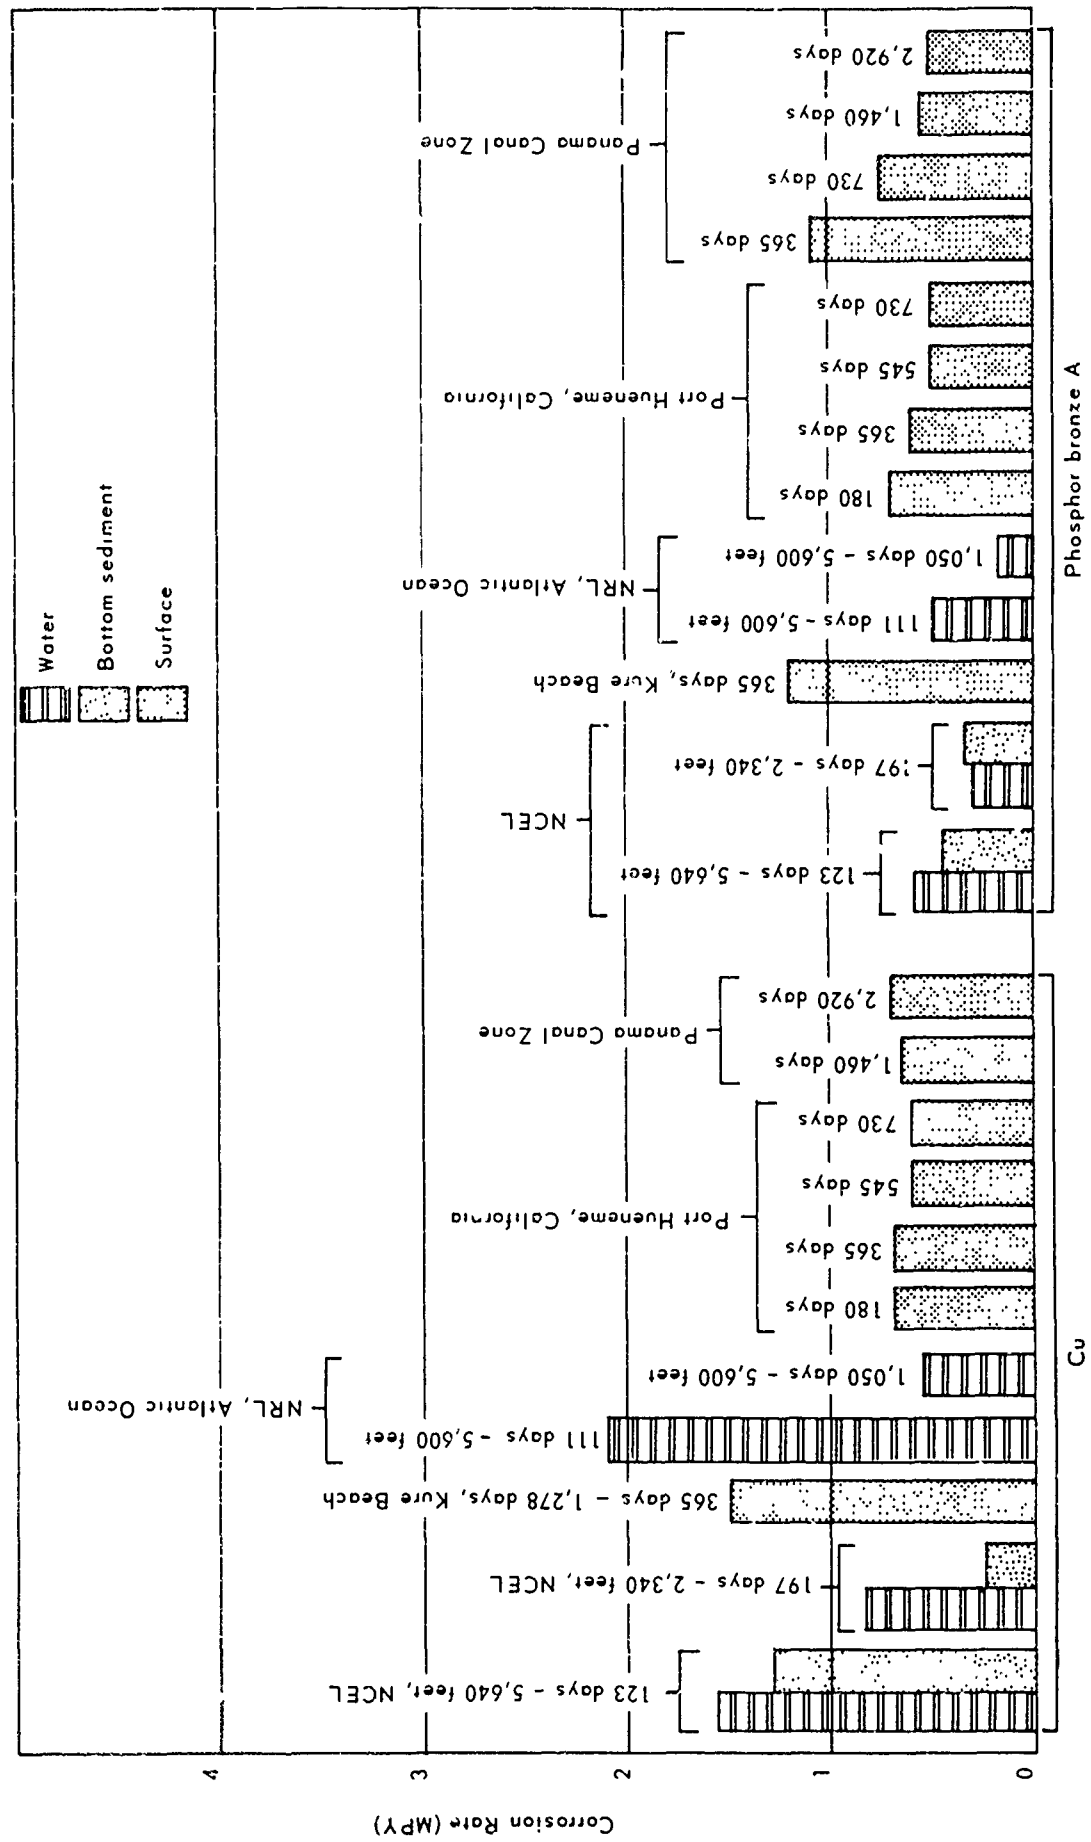
Figure 44. Corrosion of copper and phosphor bronze A at different depths in different localities for various periods of time.

The corrosion rate for copper after 365 days of exposure at the surface at Kure Beach, N. C., in the Atlantic Ocean is the same as that after 123 days at a depth of 5,640 feet in the Pacific Ocean. The corrosion rates for copper at the surface in the Pacific Ocean at Port Hueneme, California, and at the Panama Canal Zone were the same and remained constant for periods of exposure from 180 to 2,900 days (6 months to 8 years) and are somewhat lower than the rate reported at Kure Beach, N. C. They are also lower than the rates at depth in both the Pacific and Atlantic, except for 1,050 days in the Atlantic, where, again, they are the same.

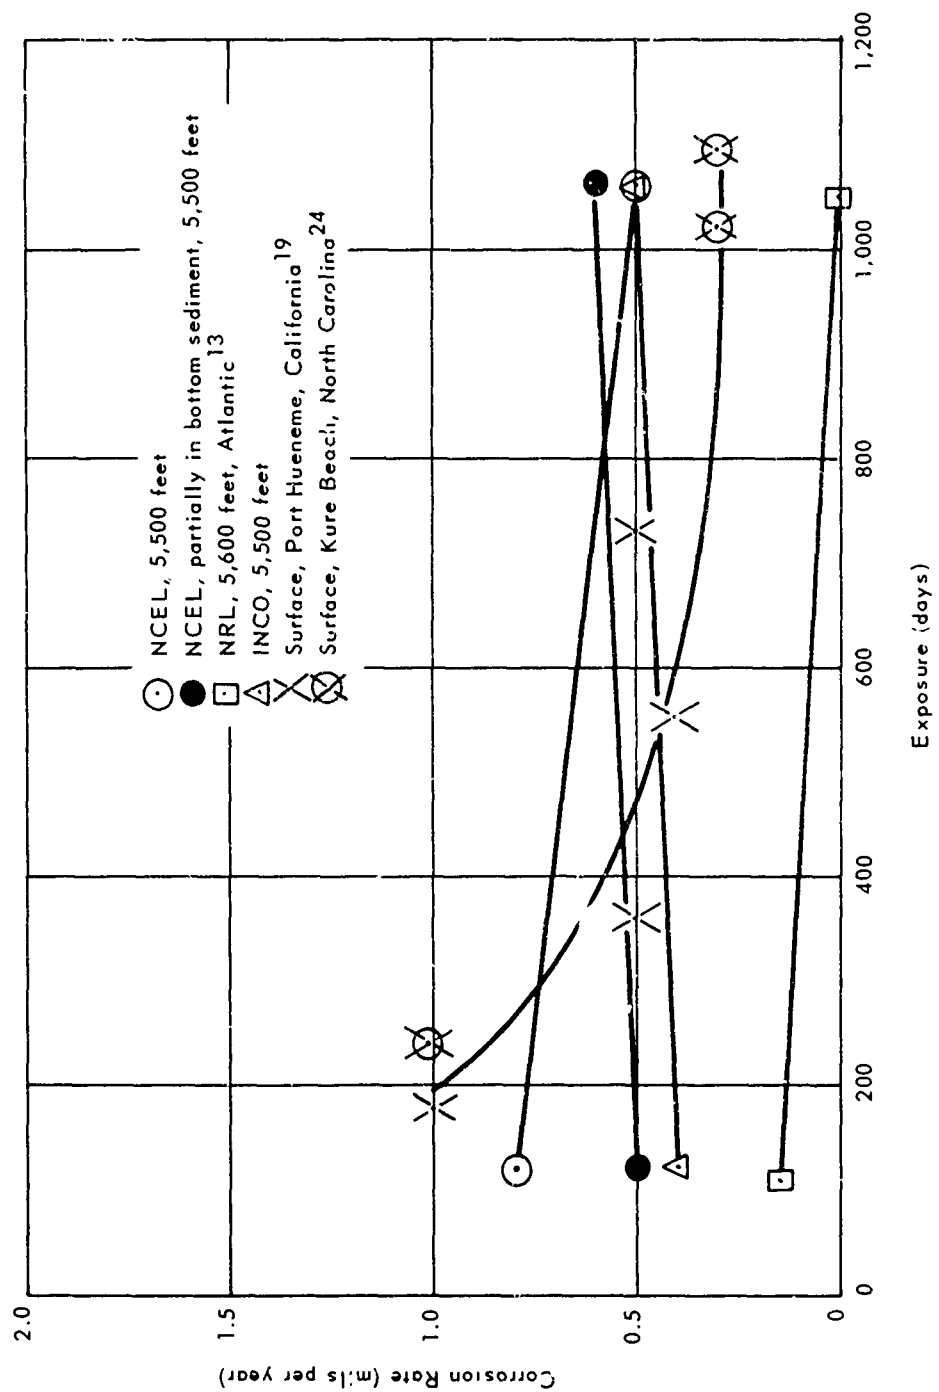
Figure 48. Corrosion of Ni - Cu 400 alloy immersed in seawater.

A comparison of the corrosion rates of Ni - Cu 400 alloy immersed in seawater at various depths is shown in Figure 48. The initial corrosion rates at a nominal depth of 5,500 feet for 123 days were lower than those at the surface, but were slightly higher after 1,064 days of exposure. However, the corrosion rates of this alloy exposed at a depth of 5,600 feet in the Atlantic Ocean were much lower than those at a nominal depth of 5,500 feet in the Pacific Ocean and lower than those at the surface.
